RE: QUARTERLY PROGRESS REPORT FOR THE AVTEX FIBERS SUPERFUND SITE FOR THE PERIOD JANUARY 1 THROUGH MARCH 31, 2021 (FIRST QUARTER)

Quarterly Inspection Report

Quarterly Inspection Report Photographic Log
Avtex Superfund Site
Front Royal, Virginia

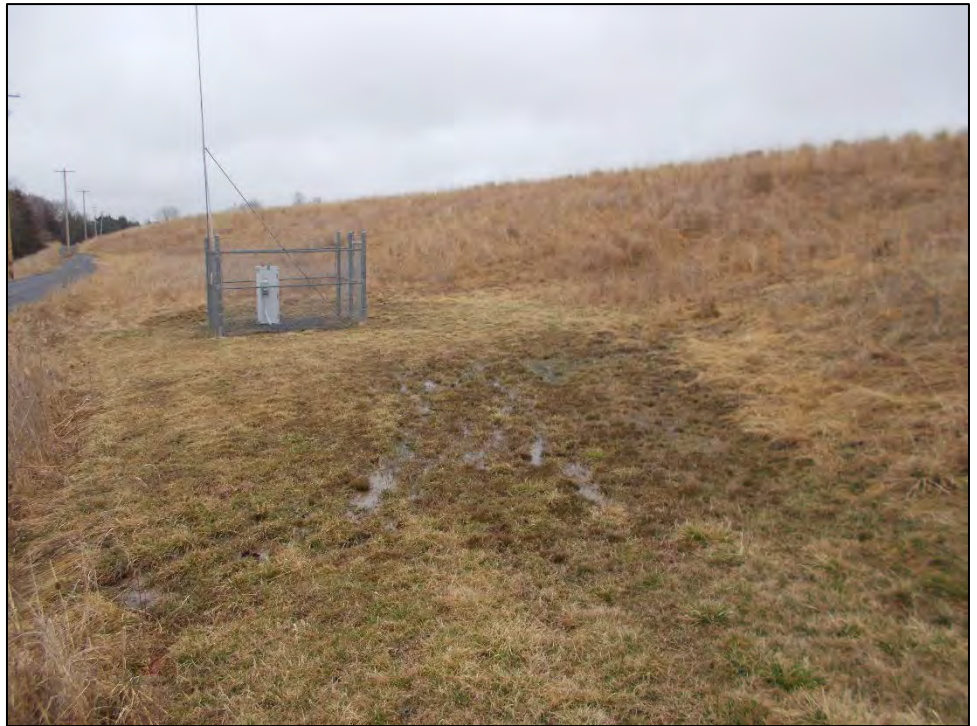
Photo Number: 1

Photo Description: Two areas of standing water adjacent to LS-2. Wet due to recent rainfall

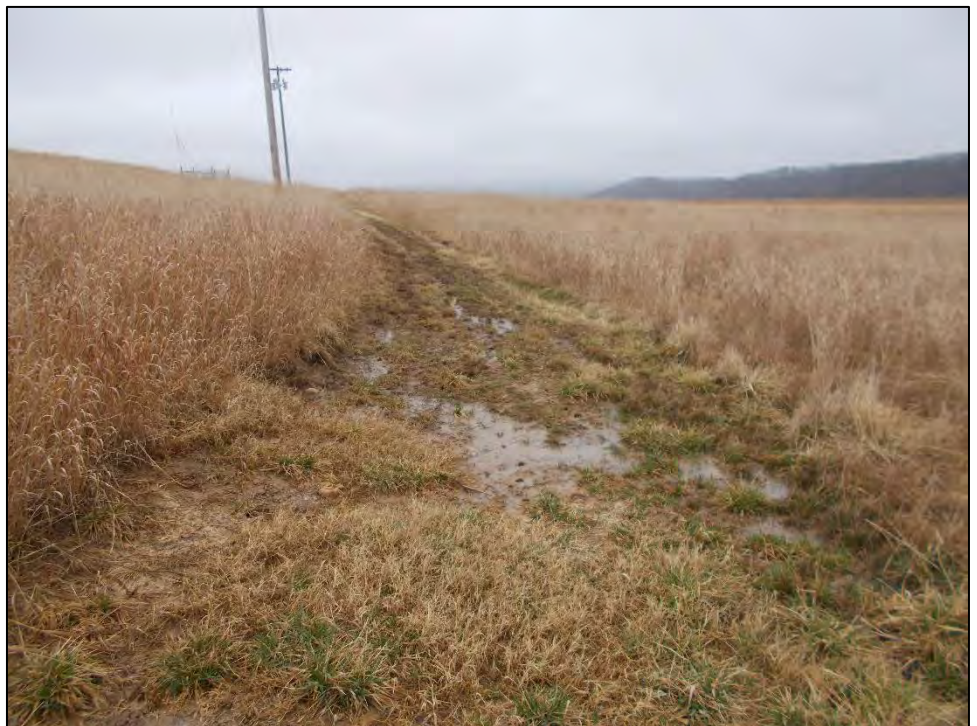
Photo Number: 2

Photo Description: Standing water on access path west of VB-4,5, & 6 (path to LS-1)

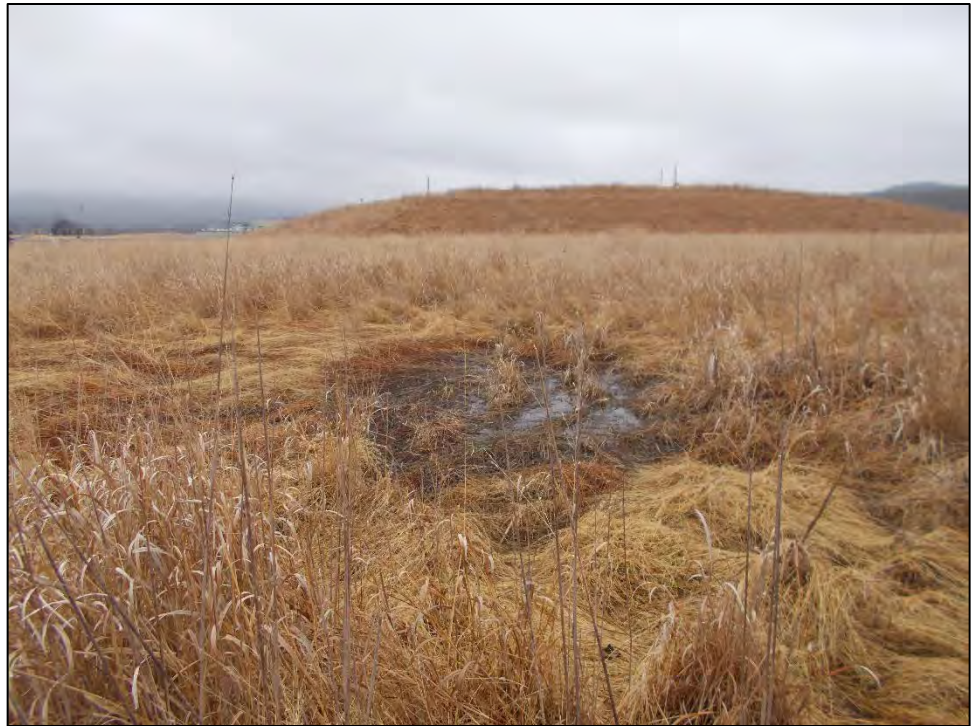
Photo Number: 3

Photo Description: Small area (approximately 10-foot in diameter) of standing water due to recent rainfall with some loss of vegetation.

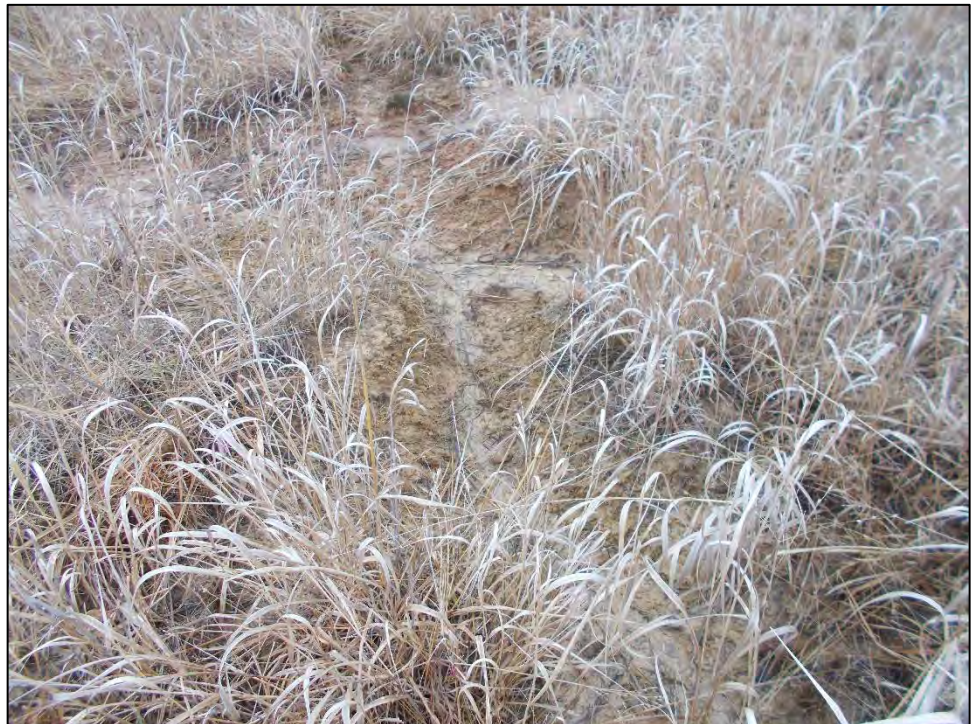
Photo Number: 4

Photo Description: : Bare soil (~10' x30') with rills southeast of VB-2&3 (Sediment basin between NLF and VB-2&3). Appears stable. Water flowing due to recent rain.

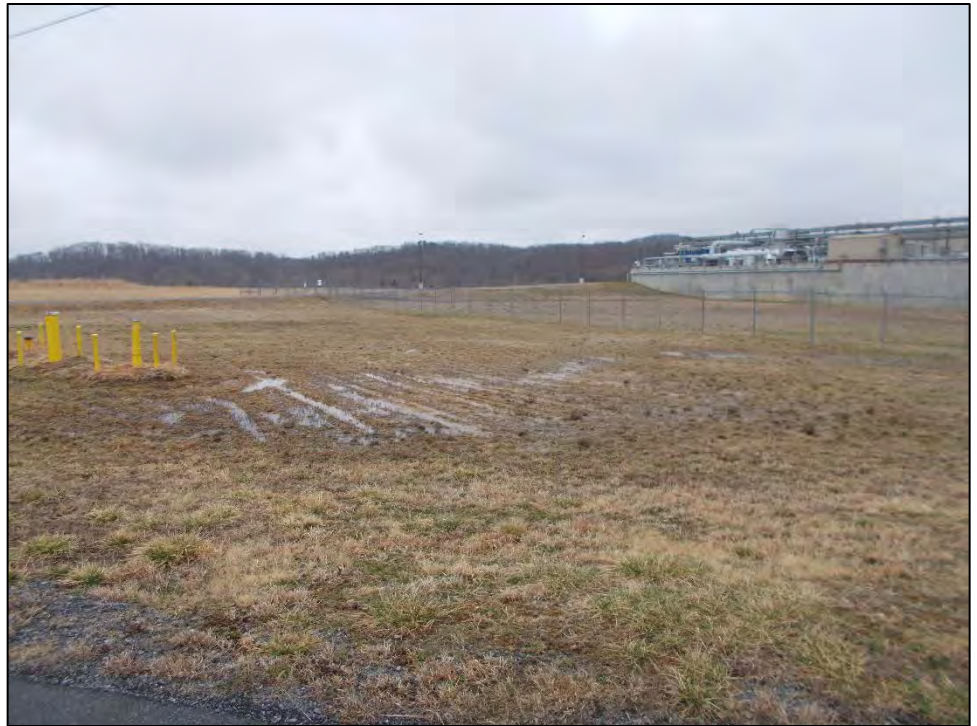
Photo Number: 5

Photo Description: Area around wells 103/203/303 – wet due to recent rainfall.

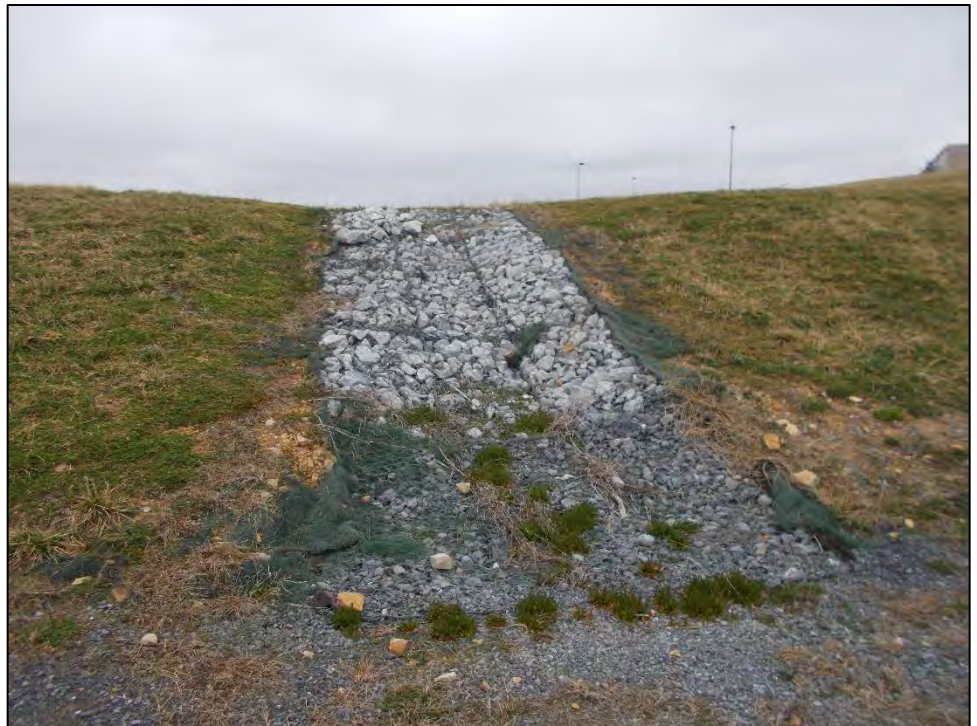
Photo Number: 6

Photo Description: Bare patches and exposed matting at down chute in south side of VB-10.

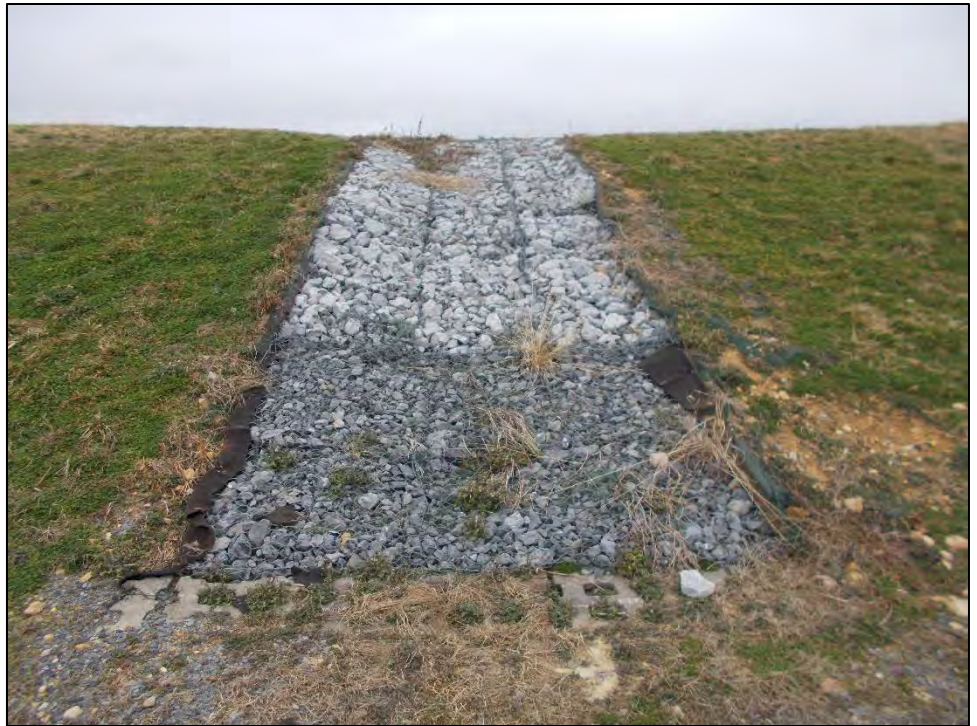
Photo Number: 7

Photo Description: Bare patches and exposed matting at down chute on south side of VB-10.

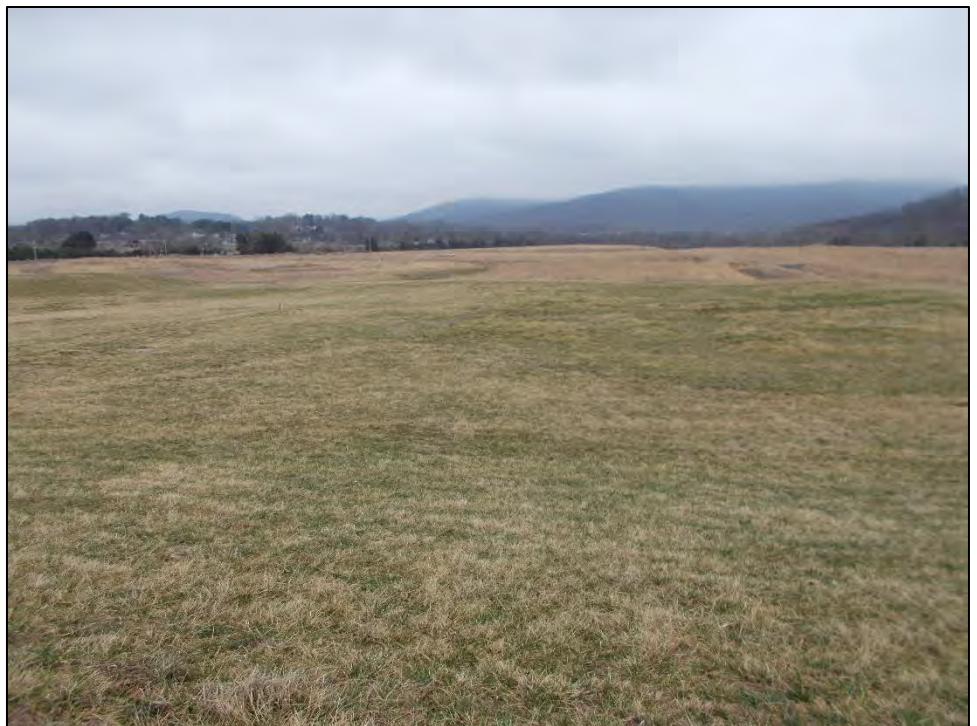
Photo Number: 8

Photo Description: VB-10 after repairs.

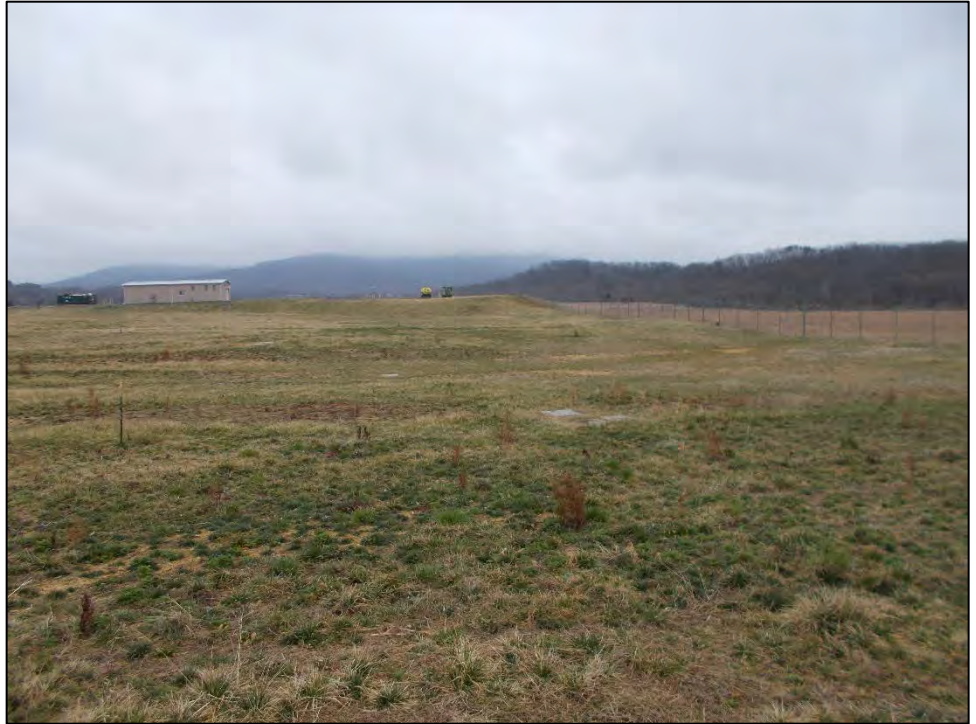
Photo Number: 9

Photo Description: Former settlement on VB-9 (30' x 40); repairs complete and grass growing.

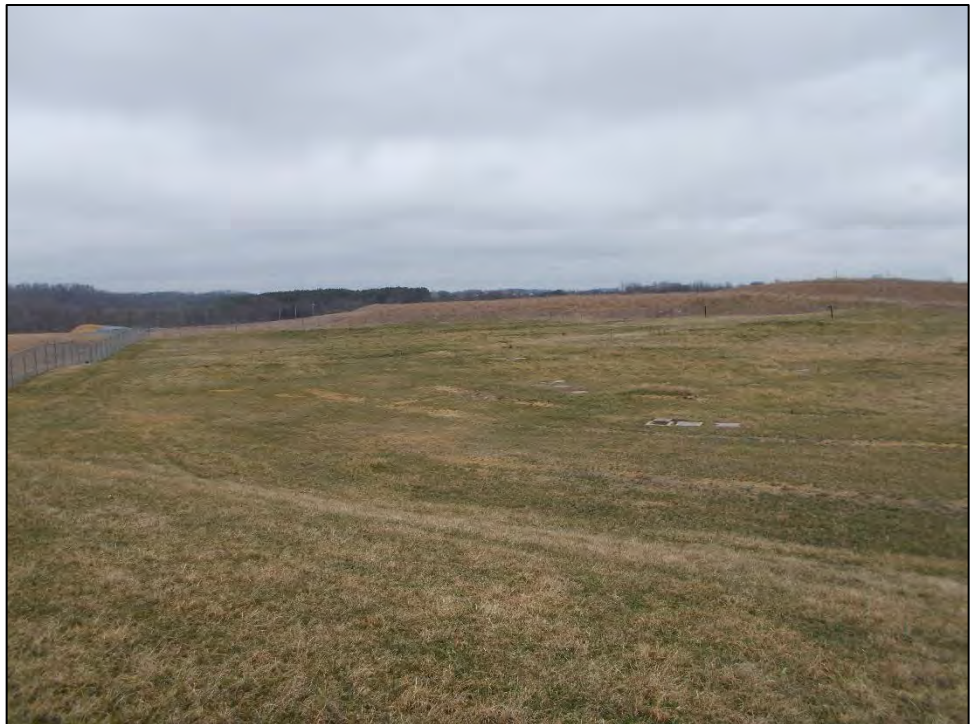
Photo Number: 10

Photo Description: Former settlement on VB-9 (30' x 40); repairs complete and grass growing.

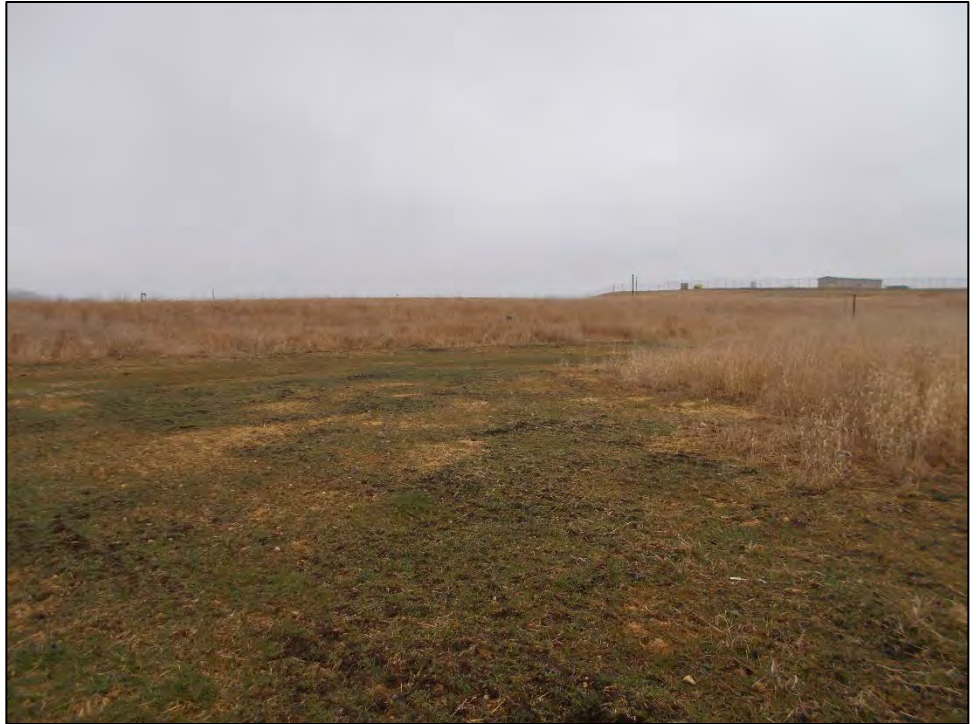
Photo Number: 11

Photo Description: Former areas of settlement in front of inlets between SB-3 and SB-2 – repairs complete and grass growing.

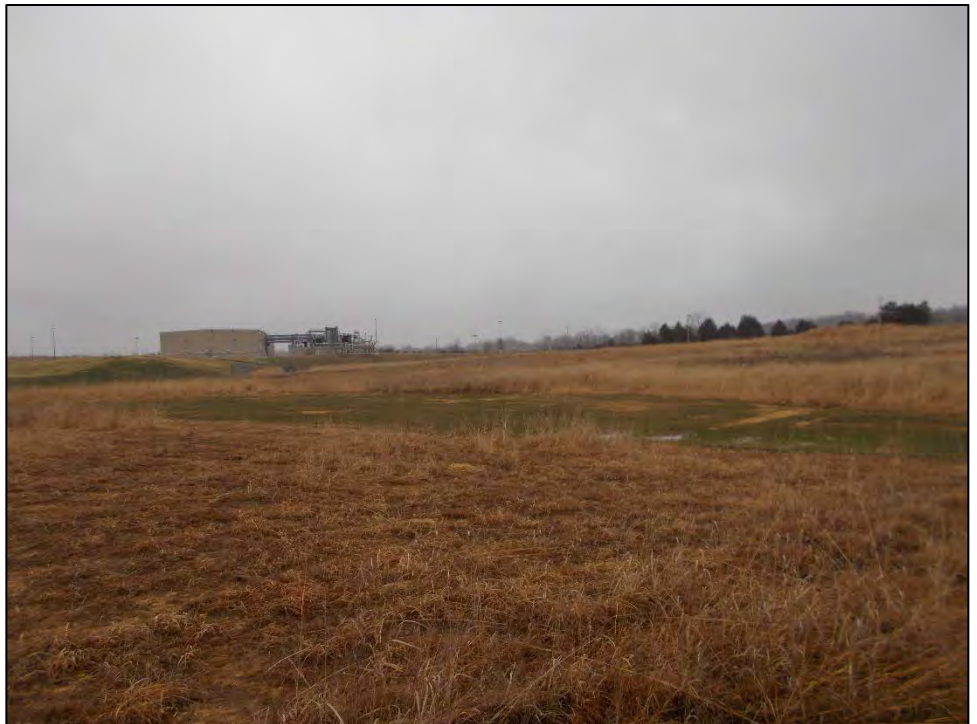
Photo Number: 12

Photo Description: Former area of settlement on FAB-3 – repairs complete and grass growing.
